AFOSR Grant Number 80-0130  
Annual Technical Report  
March 1982

ANALYSIS OF LONG BONE AND VERTEBRAL  
FAILURE PATTERNS

UNIVERSITY OF FLORIDA  
GAINESVILLE, FL 32610

Jo Ann C. Eurell, DVM, MS, PhD

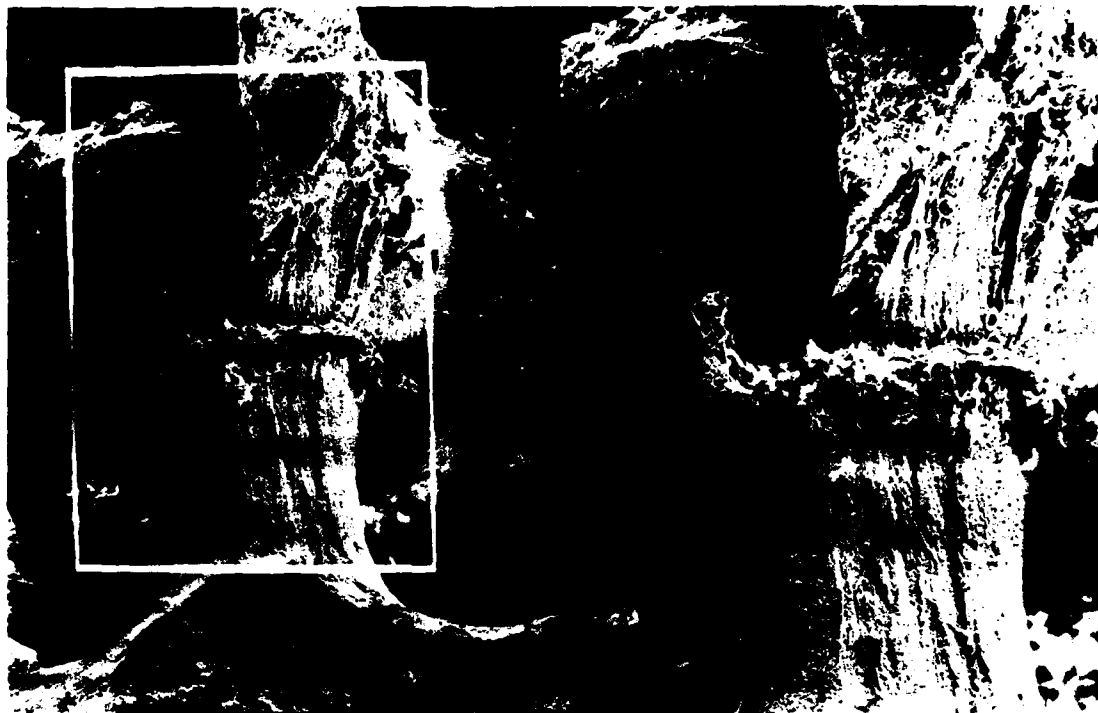
Figure 5. SEM of end zone near disc. Healed microfracture is present. G74 L<sub>3</sub>.

Trabecular microfractures were present, but they were few in number (1 to 3 per vertebral body). The microfractures in figures 5 and 6 appear

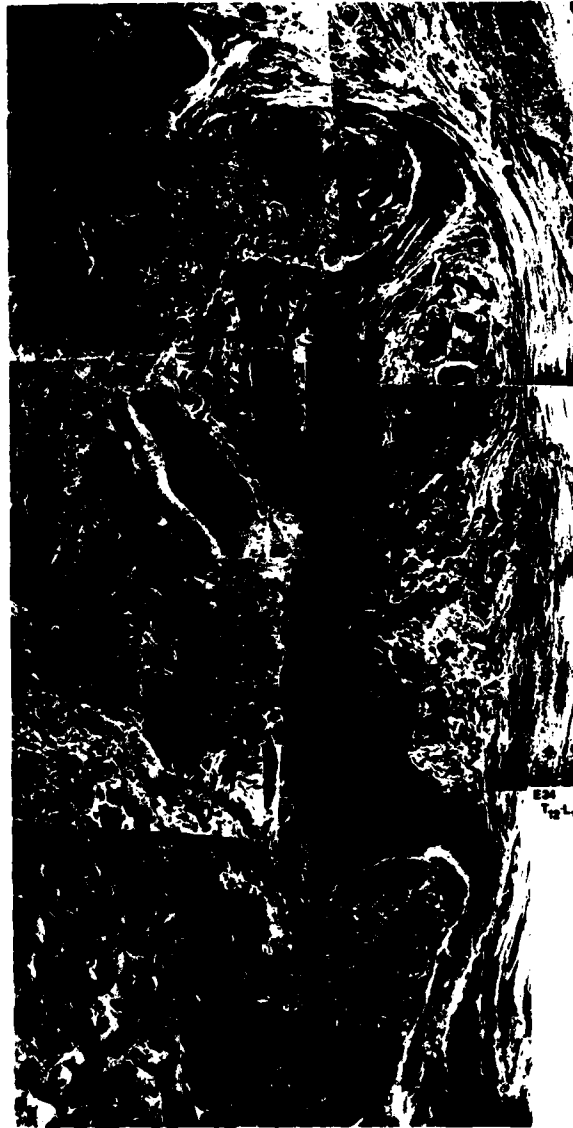
Figure 12. SEM of anterior disc. Note osteophytes. E34 T<sub>12</sub>-L<sub>1</sub>.

The overall height of the individual disc spaces in this animal was decreased (Fig. 11) compared to the 6 month P-I animals. The anterior margins of the vertebral bodies had numerous osteophytes which often bridged the intervertebral space (Fig. 12). Endplate channels were also noted as seen in figures 13 and 14.
